Performance Surety Division

LANL MIRROR:

Reflecting Incidents,
Actions, & Lessons
at Los Alamos
National Laboratory

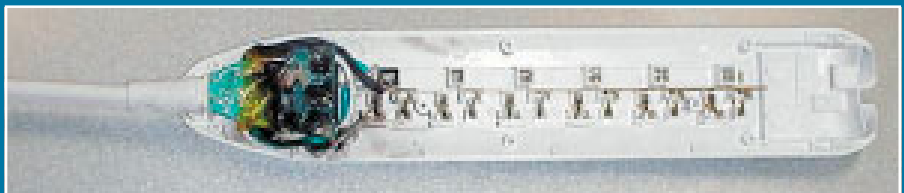
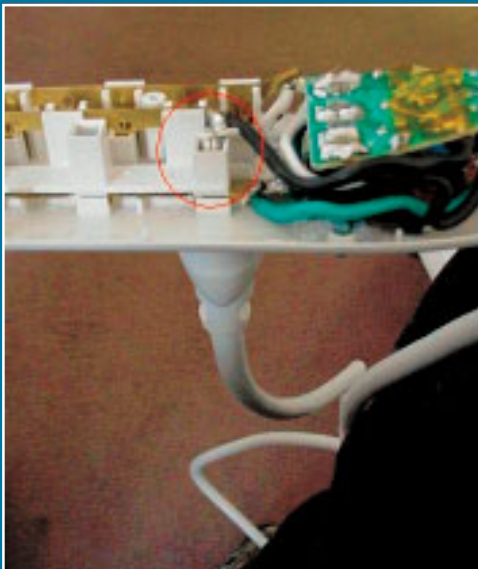
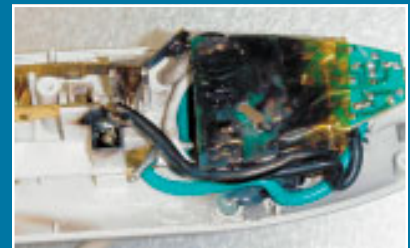
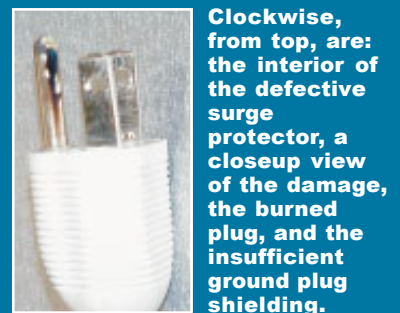
On May 7, 2004, at TA-53, Building 1, Room B113, as a Technical Mission Support Group (LANSCE-10) employee was attempting to plug a computer monitor power cord into a surge protector, the device sparked and caused an electrical arc and loud popping noise. At the time, the surge protector was energized and plugged into a wall receptacle. The surge protector was a Stanley 6-outlet SurgePro™ Power Strip with a 6-foot power cord (Model STS164) manufactured by Belkin Components. The affected employee reported muscle soreness in her right arm. Her symptoms were most likely the result of reactive motion induced by the arc flash and not by an electrical shock. The causes of this occurrence were defective or failed part and inadequate design output scope. After the event, the LANSCE electrical safety officer inspected the surge protector and another one of the same make and model. Both had similar internal wiring deficiencies and insufficient ground plug shielding.

Clockwise, from top, are: the interior of the defective surge protector, a closeup view of the damage, the burned plug, and the insufficient ground plug shielding.

Corrective Actions: (1) evaluate existing surge protectors in the LANSCE training office, (2) issue a LANL-wide alert on the defective surge protector, and (3) research LANL procurement requirements for surge protectors.

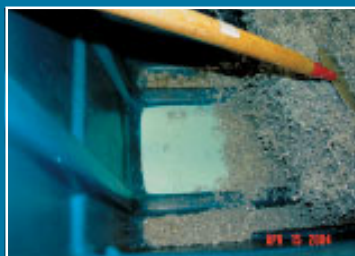
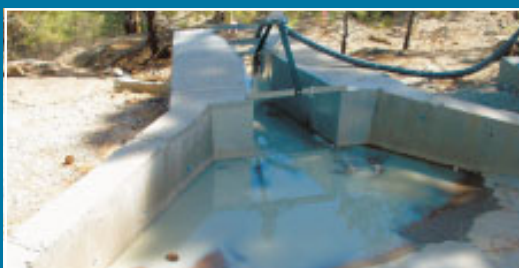
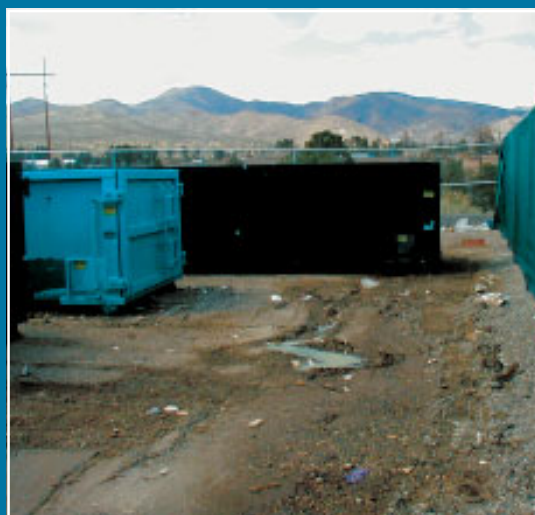
On April 14, 2004, at TA-60, Building 85, the Material Recycling Facility (MRF), while an Ace Metals driver was loading a 15-yard roll-off bin onto a transport vehicle, about 300 gallons of storm water and cutting oil discharged onto the soil and storm drain. The bin came from TA-50, Building 54. One causal factor associated with this occurrence was that the check of work was less than adequate in that the driver failed to observe the liquid in the bin. Another cause was that job performance standards were not adequately defined. An Ace Metal representative stated that metal shavings cannot be recycled when they are wet. Storm water collected in the bin because it was uncovered and was stored outside the MRF. Corrective Actions: (1) review the metal shavings recycling process and develop alternatives for preventing entry of water and (2) sample the liquid remaining in the bin and analyze it for total volatile organic compounds (VOCs), total semi-volatile organic compounds (SVOCs), and total metals.

Clockwise from top left, are the roll-off bin, the Material Recycling Facility yard, storm drain, and metal shavings in the bin.

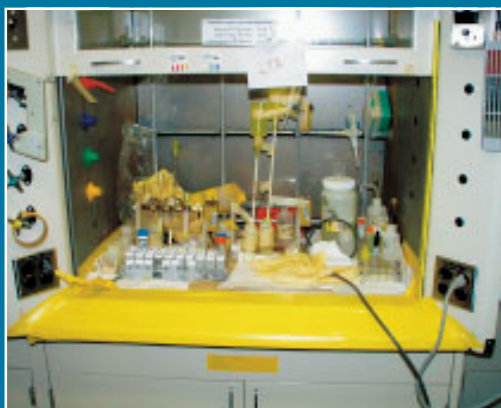
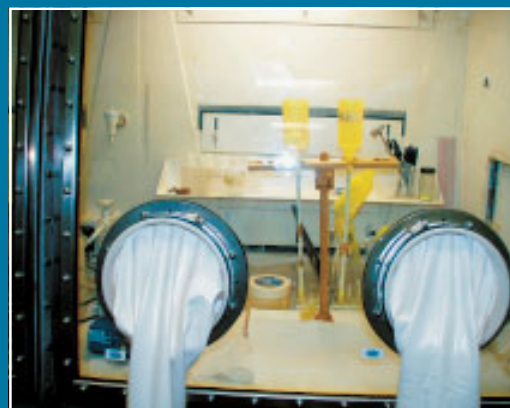
SYNOPSIS: On March 4, 2004, an Actinide Analytical Chemistry (C-AAC) employee at the Chemistry and Metallurgy (CMR) Building detected alpha contamination on her chin and lips after performing isotope separation studies involving a 3 molar nitric acid solution containing plutonium (Pu) 239 and Uranium (U) 233. The employee immediately notified a radiological control technician (RCT), who performed a direct survey of the employee's face and measured 18,000 dpm of alpha contamination on her chin and lips. Health Physics Operations (HSR-1) and Occupational Medicine (HSR-2) specialists took appropriate decontamination actions. Investigators concluded that the employee most likely accidentally cross-contaminated herself during the course of performing work.

These photos demonstrate the engineering control applied by C-AAC. At left is the experiment location where the event occurred. The experiment was moved to a glove box, right photo, with a window between the operator and the experiment.

CAUSAL ANALYSIS: Investigators determined that the primary Integrated Safety Management (ISM) System causal factor in this event was a failure by management to adequately

implement administrative work controls, which investigators believe was a result of infrequent interaction between supervisors and managers and their employees concerning radiological work practices. The investigators said a contributing ISM failure was the failure of line managers to recognize and act upon previous events of a similar nature involving the employee.

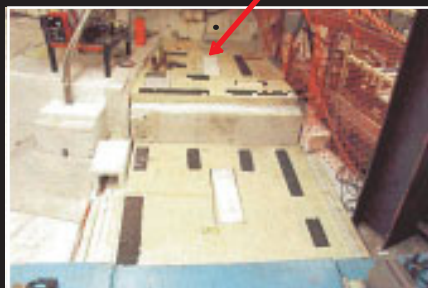
Chopper shielding block is located next to the bulk shield.

Event occurred in LANSCE ER-1.

of the chopper, although an area status board identified the fact that the beam was on. The investigation revealed that engineering controls had not been implemented to prevent the neutron leakage from the adjacent flight paths and that inadequate formal administrative controls resulted in a failure to ensure verification of shielding configuration prior to authorization of particle beam operation. In addition, formal work controls were not implemented to ensure that workers interfaced with RCTs and obtained surveys of the work area before entering the area, or that the work area was controlled in accordance with the requirements of 10 CFR 835.

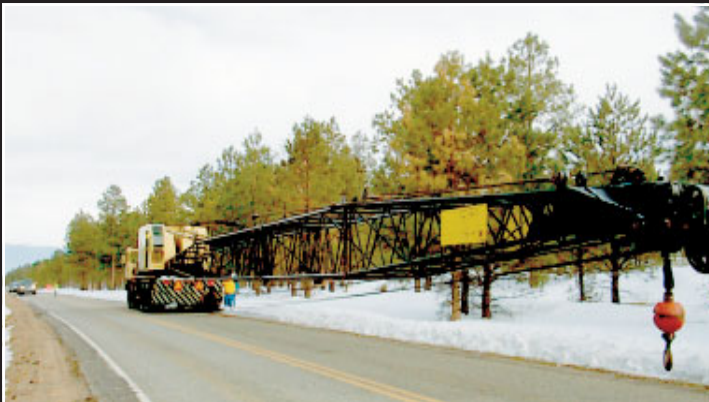
The 1972 P&H crane's 100-foot boom struck and severed all three phases of 13.2 kV overhead power lines as it was traveling from TA-60 to TA-15.

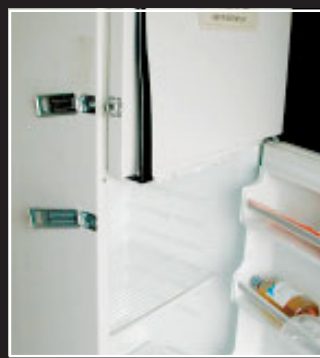
DISCUSSION: In the May 8, 2003 incident, the carpenter was tasked with installing four hasps on two refrigerator/freezers under a Skill of Craft-category work ticket. The subcontractor supervisory staff made the Skill of Craft determination for this task. The carpenter installed three hasps without incident. During installation of the fourth hasp, he created a spark when the self-tapping screw he was driving with a double-insulated cordless drill struck the refrigerator's side-panel wiring, tripping the electrical breaker and Ground Fault Circuit Interrupter. Wiring diagrams were not available for the refrigerator, which was left energized because the hazard analysis performed by the subcontractor did not adequately consider energized equipment in this Skill of Craft task hazard analysis. The employee was wearing the proper Personal Protective Equipment, consisting of safety glasses and dielectric gloves. Investigators were told that other hasp installations had previously been performed at the Facility under the same conditions without incident. An Activity Hazard Analysis was not completed prior to the work because the task was incorrectly

Refrigerator/freezer and the hasps installed by carpenter

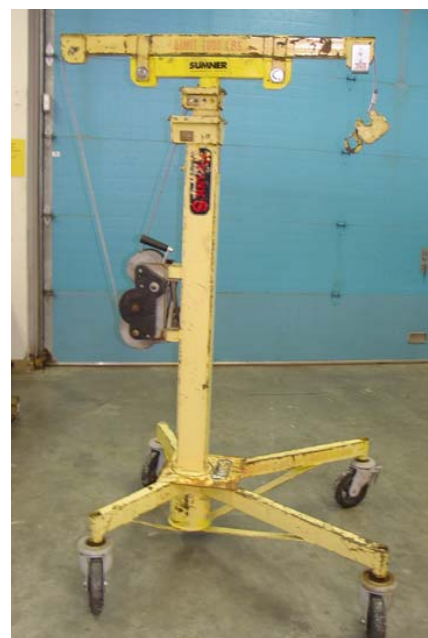
Figure 1

February 19, 2004 during a routine safety walkaround, a LANSCE-10 ES&H Team member discovered a portable hoist (Figure 1) that had been delivered to Building 18. While examining the portable hoist (ROUST-A-BOUT by Sumner Manufacturing Co.) some deficiencies in the equipment were discovered.

First, there was not an inspection sticker or documentation indicating the latest inspection. The equipment had been sent to TA-60 for KSL inspection prior to delivery to TA-53. Second, the hoist did not appear to be in a good working condition as evidenced by the rusty condition of equipment parts (Figure 2). Third, the steel pin in the shackle had been replaced with a bolt not rated for supporting a load (Figure 3). This pin is weight rated based on the load limit. This hoist has a load limit of 1000lbs or 1500lbs depending upon the lift configuration. Fourth, the operator's manual had been exposed to the natural elements and was not readable. The document was brittle and broke into pieces when removed from the protective container attached to the equipment. Without this document, the operator does not have information about the load limits for specific lift configurations. Due to these deficiencies this hoist was returned to the supplier and the supplier was asked to correct the deficiencies.
